Cleaning water drains

All models

Revision: Model 140 added.

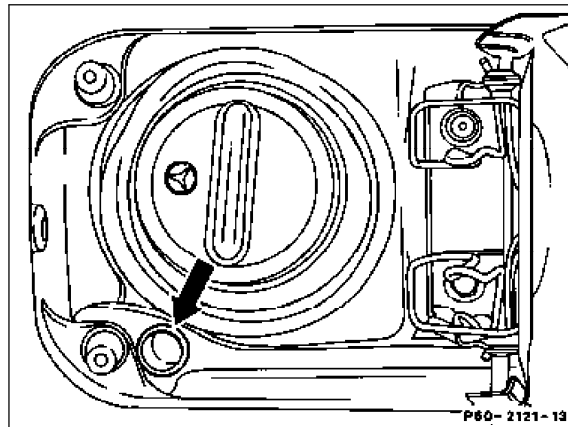
- Upper fill-in well

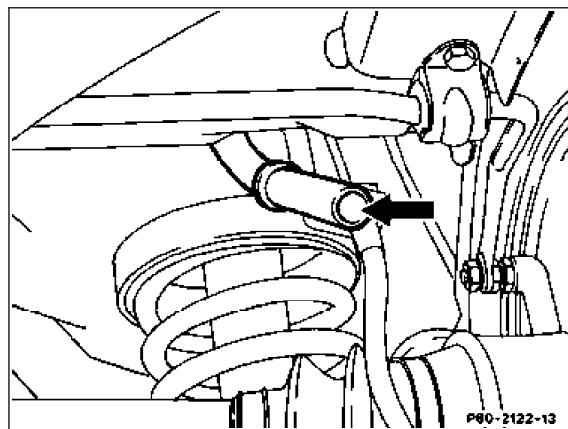
Models 107, 123, 124, 126, 201

- Lower fill-in well

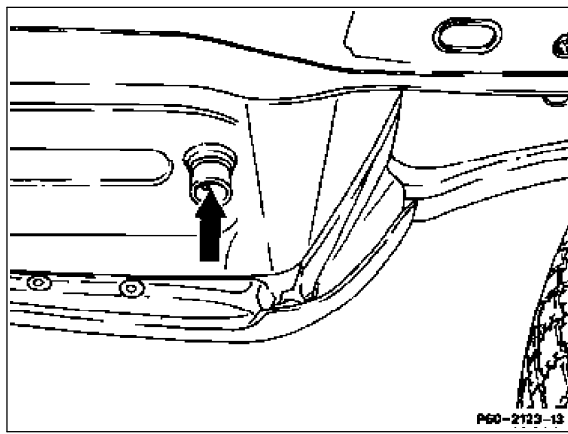
Models 107, 123, 124, 126, 140, 201

- Rear fender

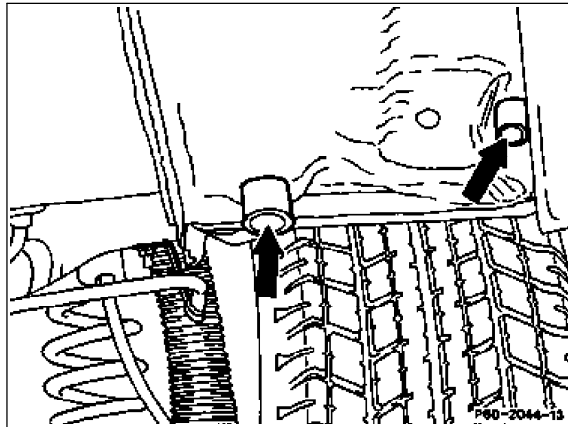
Model 129

- Rear fender
- Tank filler well, below

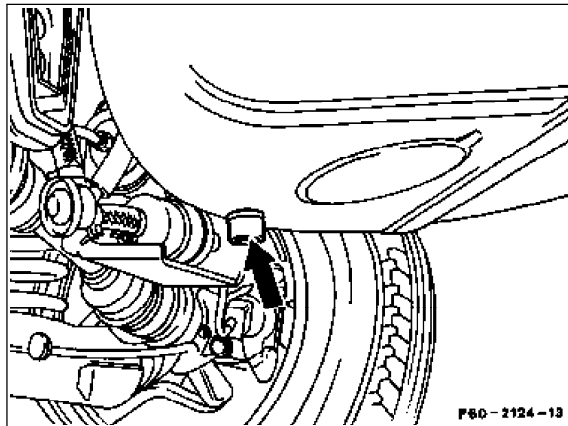
- Spare wheel well

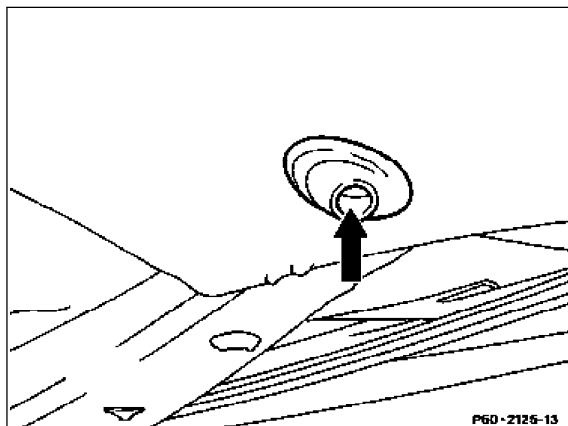
Models 123, 124, 126, 129, 140, 201

- Side member

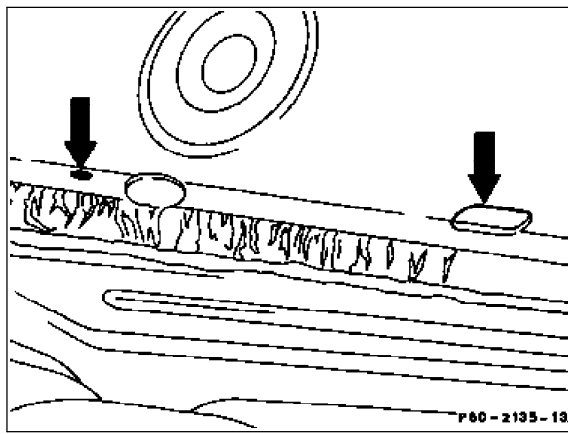
Model 107

- Side member front

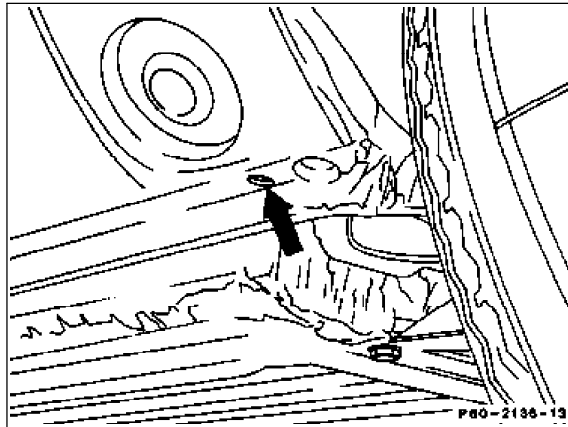
Model 107

- Side member rear

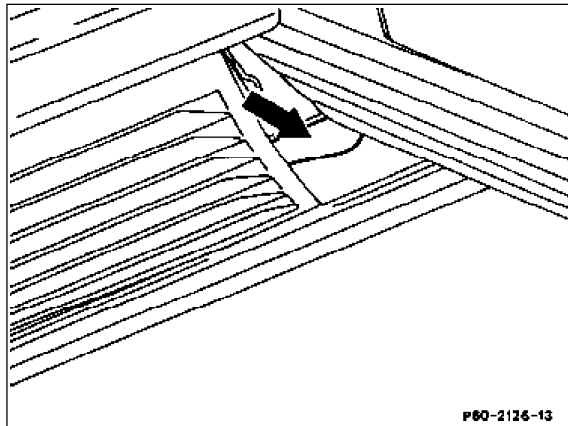
Model 107

- Side member connecting range front wall pillar

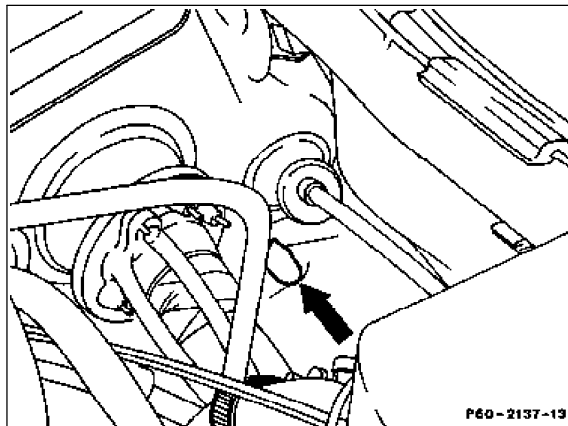
Model 123

- Engine compartment top

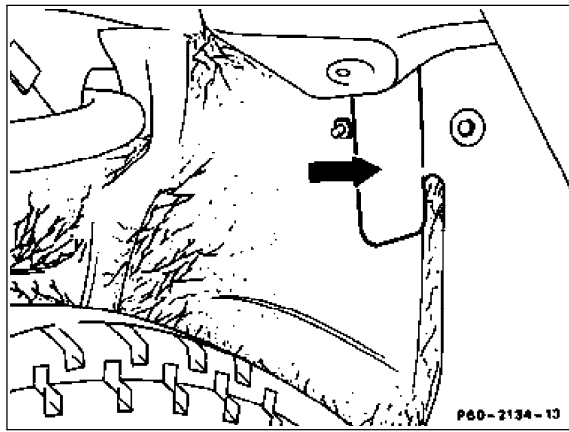
Model 123

- Engine compartment below

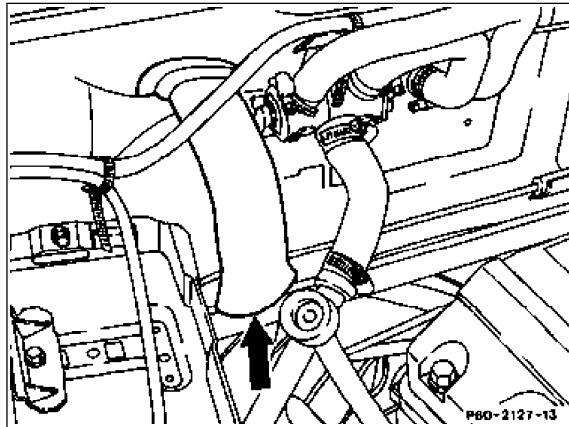
Model 123

- Water box

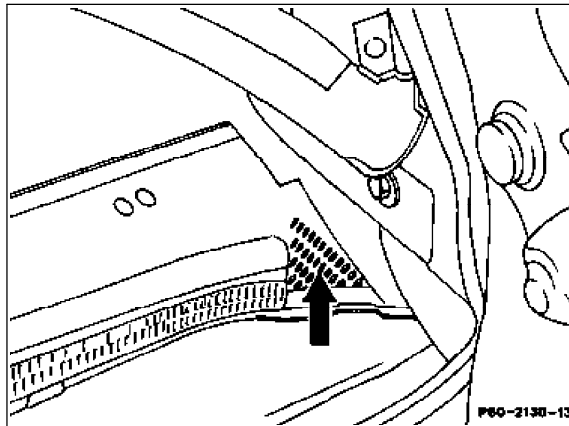
Model 126

- Drain bores in cover on air intake

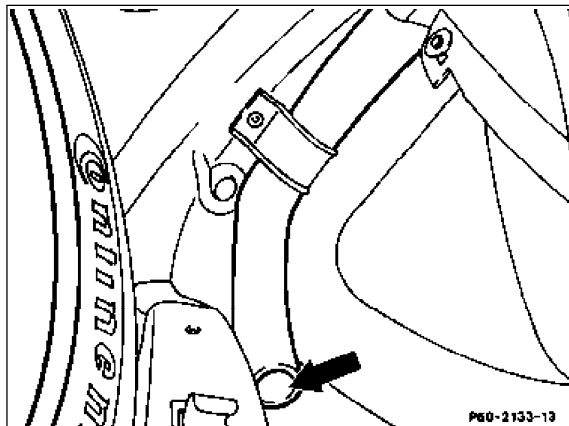
Model 126

- Water box, outer

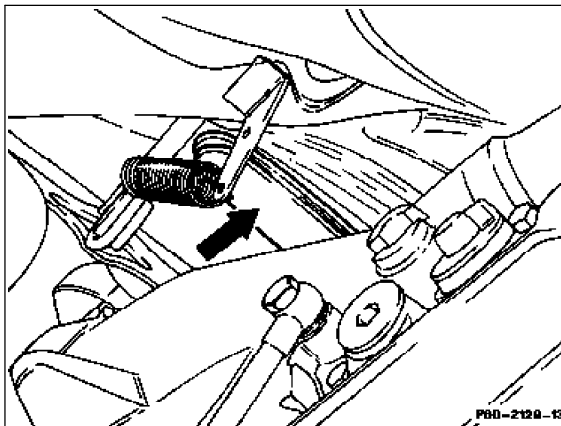
Model 126

- Water box, center

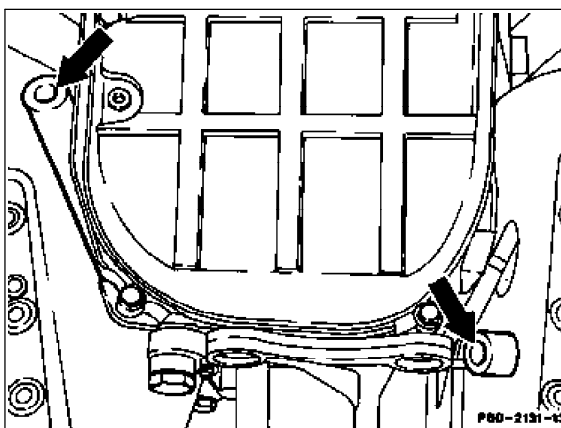
Models 124, 126, 129, 140

- Air conditioning

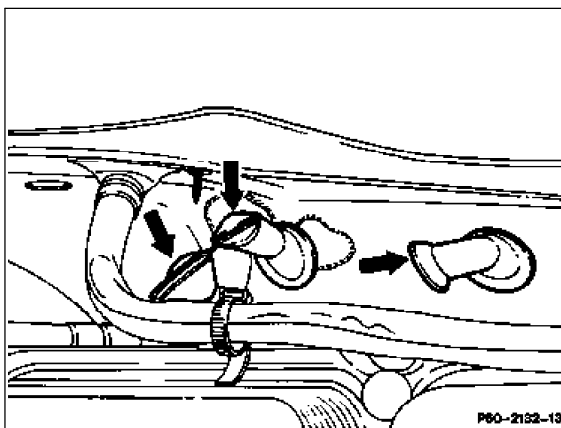
Models 124, 126, 129, 140

- Heating and air conditioning (in transmission tunnel)

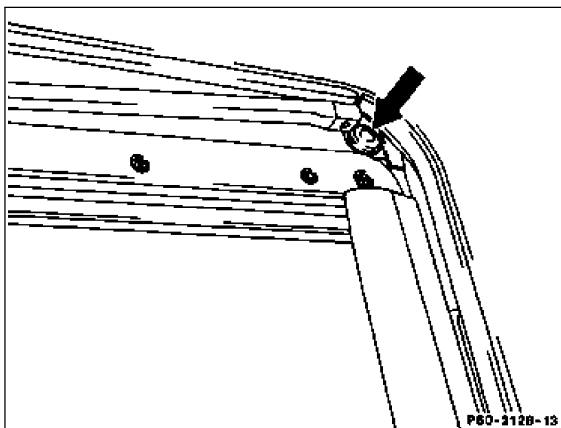
All models

- Sliding roof front

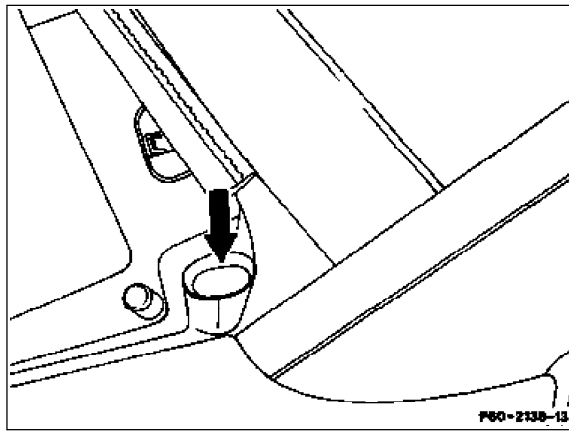
Models 124, 129, 140, 201

- Front wall pillar top

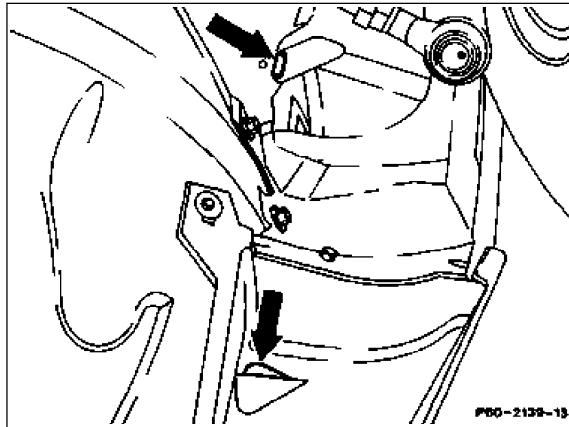
Models 124, 201

- Front wall pillar below (arrow top)
- Units compartment (arrow below)

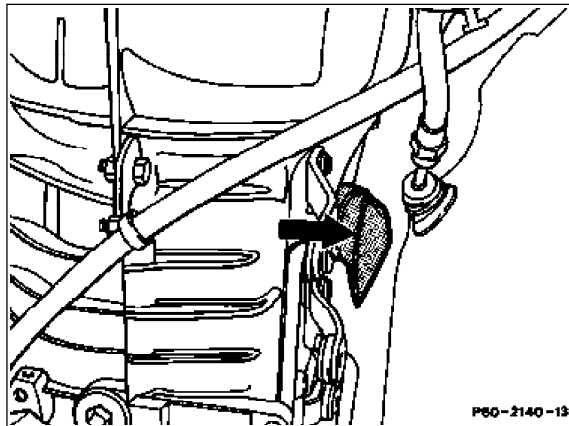
Models 124, 201

- Water box

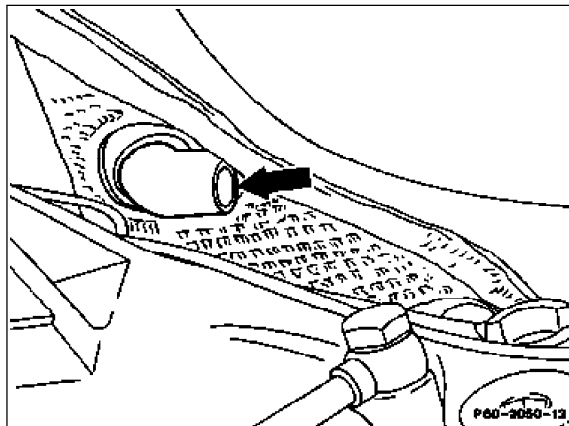
Model 129

- Water box

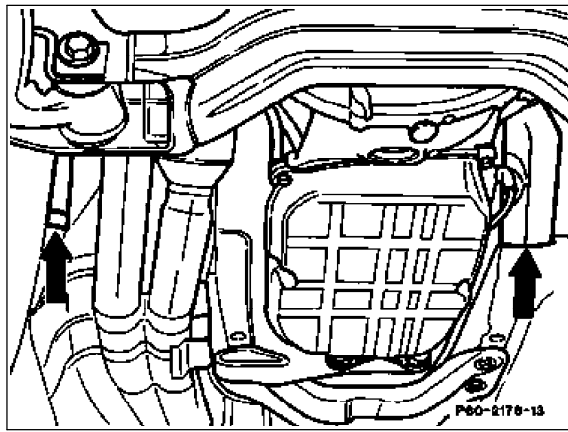
Model 140

- Water box

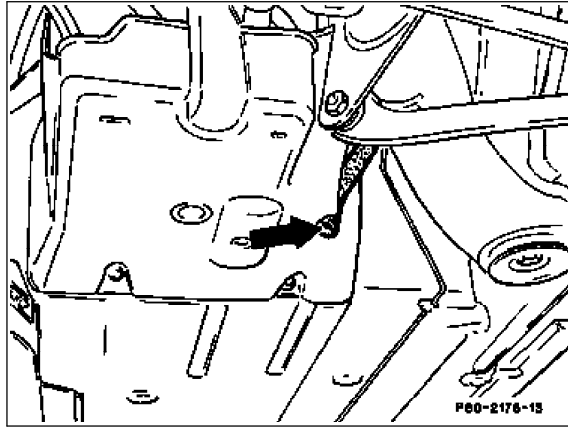
Model 140

- Lower fill-in well

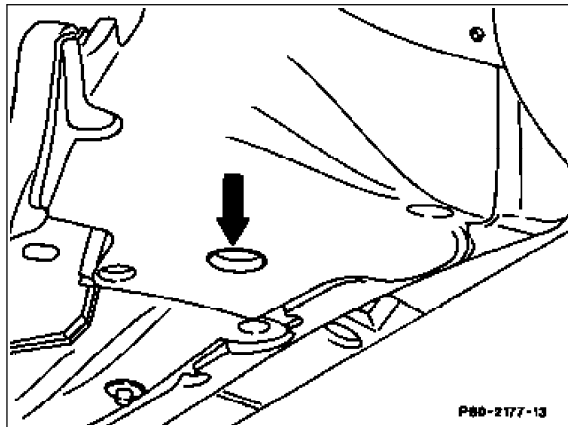
Models 129, 140

- Front wall pillar bottom

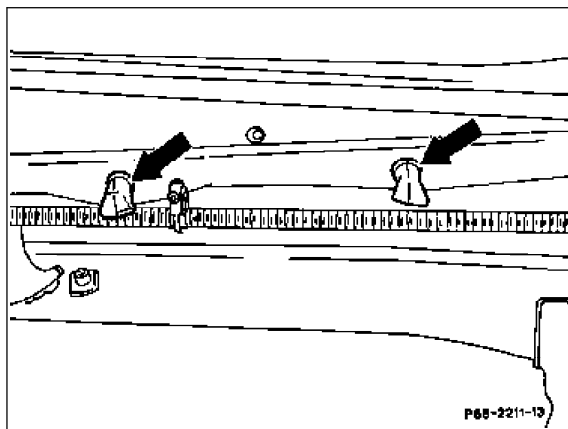
Model 140

- Rear air conditioning system
